Architect: Michael Dennis & Associates

McCULLOUGH STUDENT CENTER RENOVATIONS

Middlebury College
Middlebury, VT

Completed: 2009

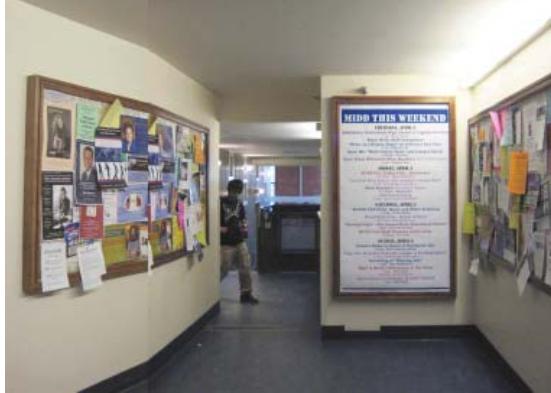
Circulation with handicapped lift prior to renovation

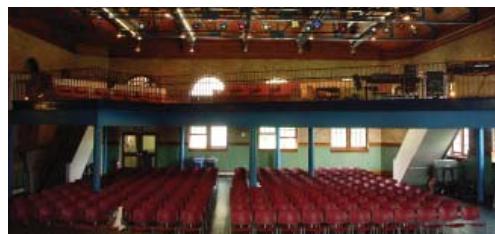
House seating with mezzanine prior to renovation
